UNITED STATES ENVIRONMENTAL PROTECTION AGENCY

RE: Request for Information (RFI) Pursuant to Section 308 of the Clean Water Act
Canadian Pacific Railway – Oneonta Rail Yard (NYR00B757)
Docket No. CWA-IR-15-014

Compliance Evaluation Inspection: Canadian Pacific Railway – Oneonta Rail Yard	
Inspection Dates: July 16, 2014 Inspection Time: 1:50 – 5:00 PM	
EPA Inspector: Katherine Mann, Physical Scientist, USEPA Region 2, DECA, Water Compliance Branch, (212) 637-4226	
NYSDEC Representative: Not present	
On-Site Representative: Kyle Moore, Foreman, 518-281-1758	
Site Information: 35 Fonda Avenue, Oneonta, NY 13820 SPDES No. NYR00B757 Owner/Operator/Permittee: Canadian Pacific Railway 120 South 6 th Street, 9 th Floor Minneapolis, MN 55402 Chad Livingston, Environmental Officer 3420 Miller Ave Davenport, IA 52803 SIC Codes: 4011 (Railroads, Line-Haul Operating) and 4013 (Railroad Switching and Terminal Establishments)

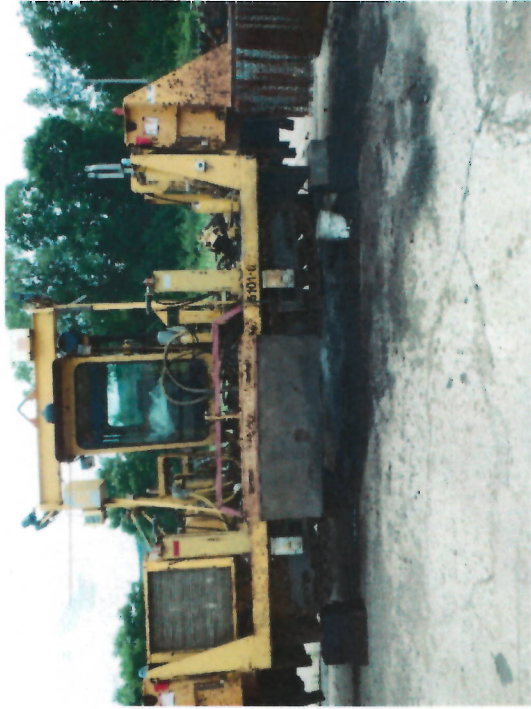
- i. As identified in photographs P7160198 – P7160204, evidence of oil and fuel spills and/or leaks was identified beneath a cribber adzer and spike puller, as well as on the pavement surface in various locations on the west side of the Site. The spills and leaks had not been cleaned up and were in areas exposed to stormwater. A nearly full bucket of oil beneath the cribber adzer was also left in an area exposed to stormwater. Effective response to spills and leaks when they occur must be coordinated by supervisory personnel, in accordance with the Facility's SWPPP and Part III.C.7.d of the Permit.

<u>Photo ID</u>	<u>Description</u>
P7160189	Overflow pipe from oil/water separator on southeast side of building 17
P7160190	Pipe from oil/water separator on the exterior of building 17
P7160191	Pipe from oil/water separator and flow path to trench drain on the east side of building 17
P7160192	PVC pipe on south side of trench drain (drains to manhole in photograph P7160194)
P7160193	PVC pipe on north side of trench drain
P7160194	Manhole that receives flow from the trench drain on the east side of building 17, located southeast of building 17. The manhole appeared to be a sanitary sewer manhole; strong sewage odors were noted during the CEI.
P7160198	Oil and fuel staining beneath cribber adzer on the west side of the Site
P7160199	Close-up of oil-filled bucket beneath cribber adzer on west side of the Site
P7160200	Oil and fuel staining on pavement beneath cribber adzer on the west side of the Site

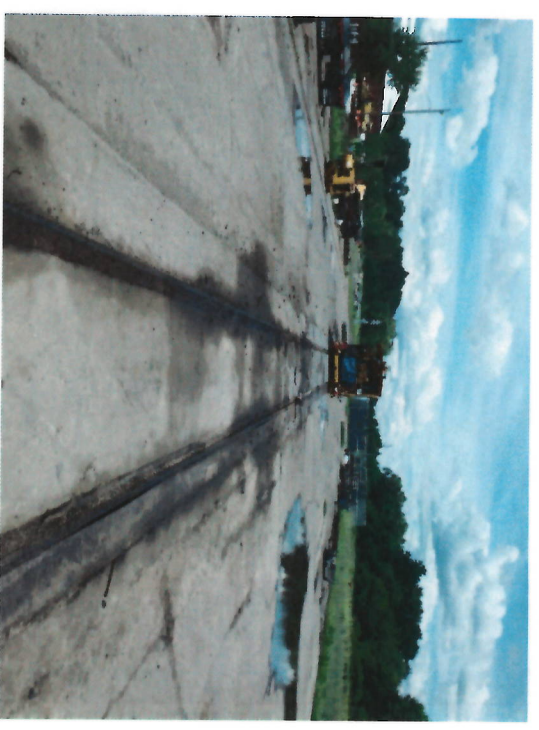
P7160201	Staining to the pavement on the west side of the Site (facing east, with cribber adzer in background)
P7160202	Oil/fuel stain beneath spike puller on the west side if the Site
P7160203	Large stain to the pavement (and additional smaller oil/fuel stains) west of the spike puller on the west side of the Site
P7160204	Close up of oil/fuel stain adjacent to the curb on the west side of the Site
P7160205	Track plates, steel anchors and other miscellaneous piles stored on pavement on the west side of the Site
P7160208	Sediment in circular drain on the south side of building 17
P7160209	Circular drain on the south side of building 17
P7160212	Sediment observed in square storm grate on the south side of building 17
P7160219	Batteries stored in yellow bins, resin in white 200-gallon tanks on metal pallets on the north side of building 17, 55-gallon drum with unknown contents on wooden pallet
P7160220	200-gallon resin tanks stored on metal pallets (or risers) and one (1) 55-gallon drum with unknown contents on wooden pallet

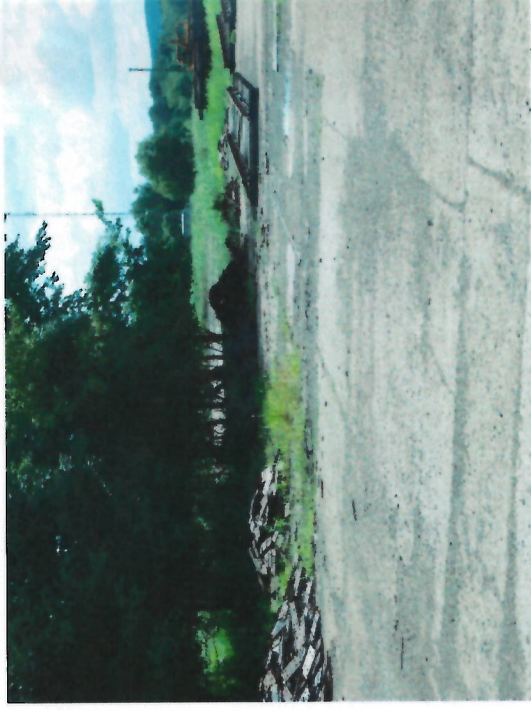
P7160205

- ii. As identified in photograph P7160205, track plates, steel anchors and other materials were stored in piles on the pavement on the west side of the Site in areas exposed to stormwater. In accordance with the SWPPP, track materials including steel and miscellaneous metal parts are stored on pallets and within a metal storage car to reduce the potential for contact with stormwater. BMPs to minimize exposure of material storage areas to stormwater must be implemented, in accordance with the Facility's SWPPP, Part III.C.7.1 and Part I.B.1.a.(2).(a) of the Permit.

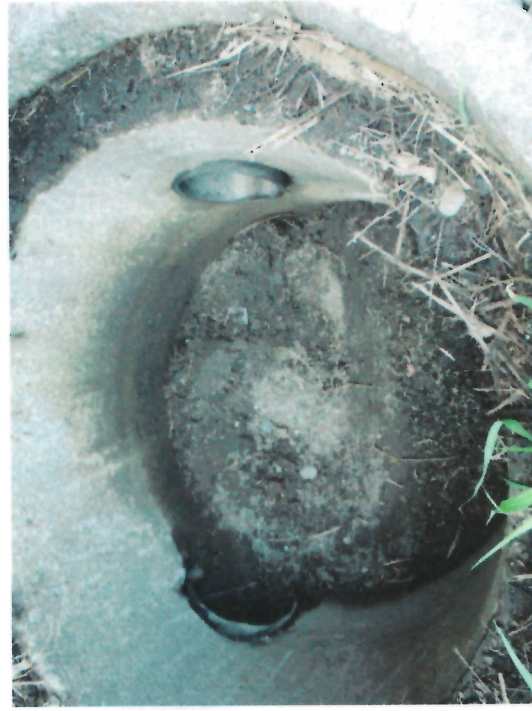
- iii. As identified in photographs P7160208 and P7160212, stormwater catch basins on the south side of building 17 were filled with sediment/gravel and in need of maintenance. Preventative maintenance of stormwater management devices, such as cleaning catch basins, must be implemented at the Facility, in accordance with the Facility's SWPPP and Part III.C.7.c of the Permit.

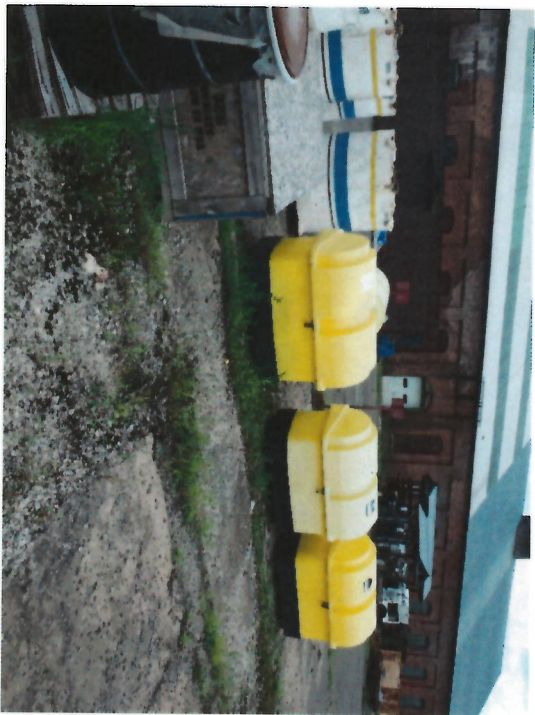
9. As identified in photographs P7160219 – P7160222, various materials, including approximately 12 200-gallon resin tanks (on pallets), nickel-cadmium batteries stored in plastic yellow bins, one (1) 55-gallon drum with unknown contents (on pallet), and 10-gallon buckets of rail grease (on pallet) were stored outdoors in areas exposed to stormwater. Such materials should be stored indoors or under cover whenever practicable. Indoor space that is no longer in use should be considered by the Facility for material storage.

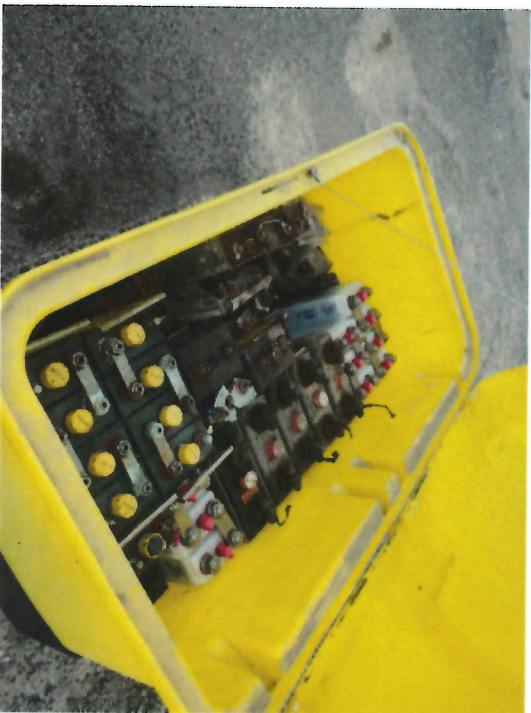
P7160221	Nickel-cadmium batteries stored in yellow plastic bins
P7160222	Approximately a dozen 10-gallon buckets (blue) containing rail grease stored on pallets on the west side of the Site
P7160223	End of pipe from building 17 on the building exterior (north side).
P7160224	PVC pipe draining from trench drain on north side of building 17 into ground
P7160228	Stormwater manhole on the southwest side of building 17
P7160229	Interior of stormwater manhole on the southwest side of building 17
P7160246	Dye test performed on trench drain on the east side of building 17 (PVC pipe on the south side of the drain)
P7160247	Flow from dye test observe in manhole identified in photograph P7160194
P7160248	Dye observed in manhole

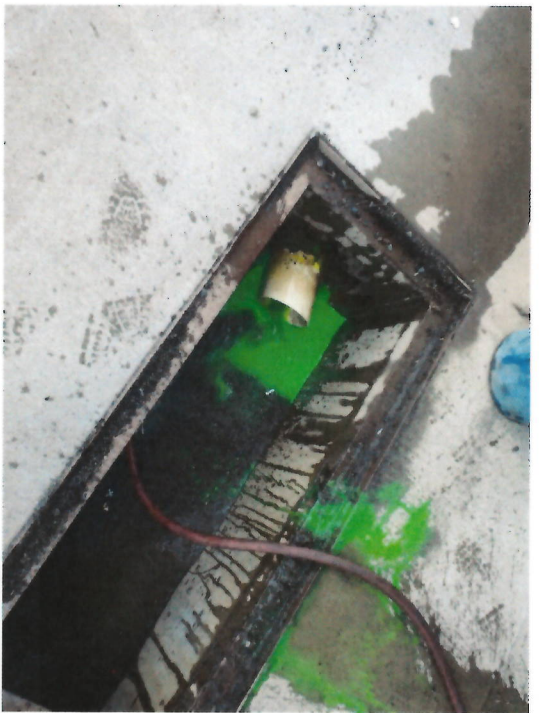
5. Based on verbal communication with Site representatives, it was unclear whether visual quarterly monitoring and benchmark monitoring were conducted at Outfall 001 as identified on the Site Map, or, if monitoring was conducted at the drain on the east side of building 17. As identified in photographs P7160246 – P7160248, a dye test was performed at the time of the CEI, which indicated that the storm drain on the east side of building 17 flows to what is believed to be the sanitary sewer. Strong sewage odors and sewage-like flow were identified in the downstream manhole that receives flow from the storm drain at the time of the CEI. If the storm drain indeed flows to the sanitary sewer instead of the storm sewer, monitoring at this location would not be appropriate, as stormwater runoff is not being conveyed to a receiving surface water body.
